# GLENHAM DAM

DUTCHESS COUNTY, NEW YORK  
INVENTORY NO. N.Y. 72

## PHASE I INSPECTION REPORT NATIONAL DAM SAFETY PROGRAM

AUGUST 1981

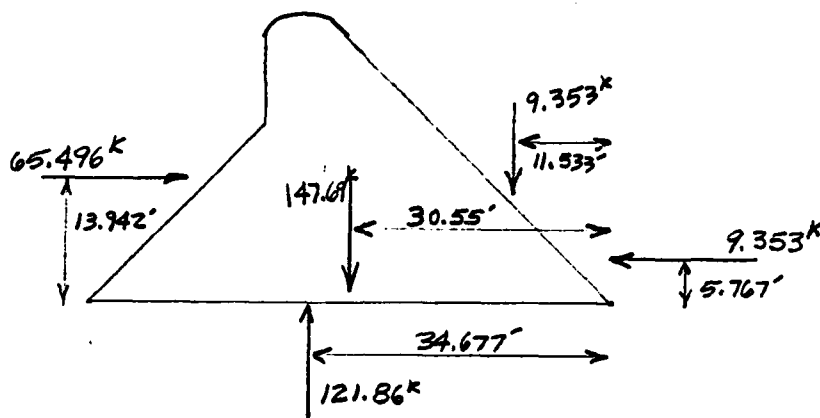
### Case III Loading Diagram

$$F.S. \text{ overturning} = \frac{(147.69)(30.55) + 9.353(11.533) + 9.353(5.767)}{(121.86)(34.677) + (65.496)(13.942)}$$

$$= \frac{4673.736}{5138.884} = \underline{\underline{0.909}}$$

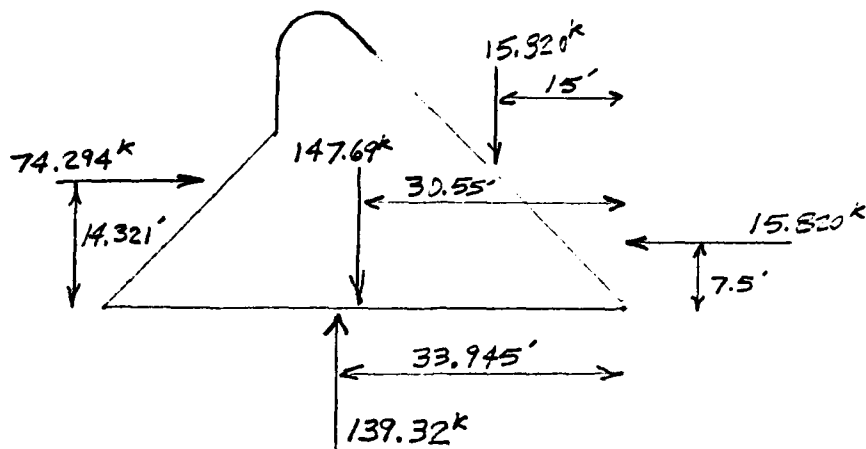
### Case IV Loading Diagram

$$F.S._{\text{overturning}} = \frac{(147.69)(30.55) + (15.820)(15) + 15.820(7.5)}{(74.294)(14.321) + (139.32)(33.945)} = \frac{4367.880}{5793.182} = 0.75$$

$$\begin{aligned} F.S._{\text{sliding}} &\Rightarrow \phi = 35^\circ \quad s = 2 \text{ ksf} \\ R &= \Sigma V \tan \phi + sA \\ &= (147.69 + 15.82 - 139.32) \cdot 7 + 2(60) \\ &= (24.19) \cdot 7 + 120 = 136.933 \\ \Sigma H &= 74.294 - 15.82 = 58.474 \end{aligned}$$
